Glen Finglas, Scottish Highlands

HYDRO MODERNISATION

SCOPE OF 2024 MODERNISATION SUPPLY

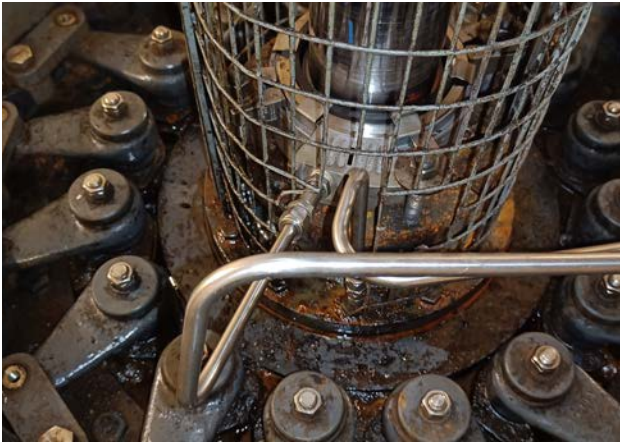
Guide Vane Mechanisms before refurbishment

Redesigning the guide vane mechanism due to issues with proper closure caused by the original loose design. Modifications were made to enhance the vanes and levers, and ringfeder locking rings were introduced to securely fasten the guide vanes into place on the levers.

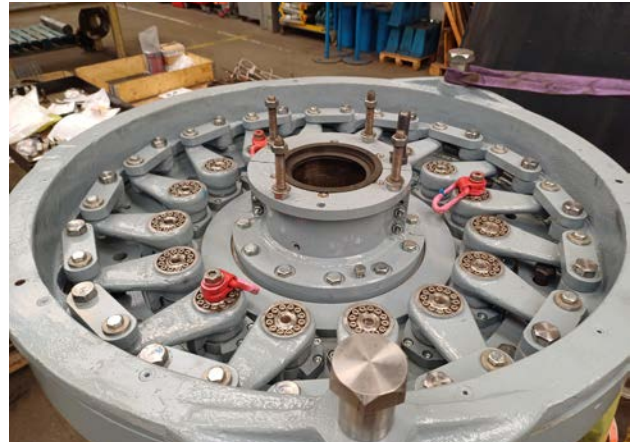
Redesigned Guide Vanes

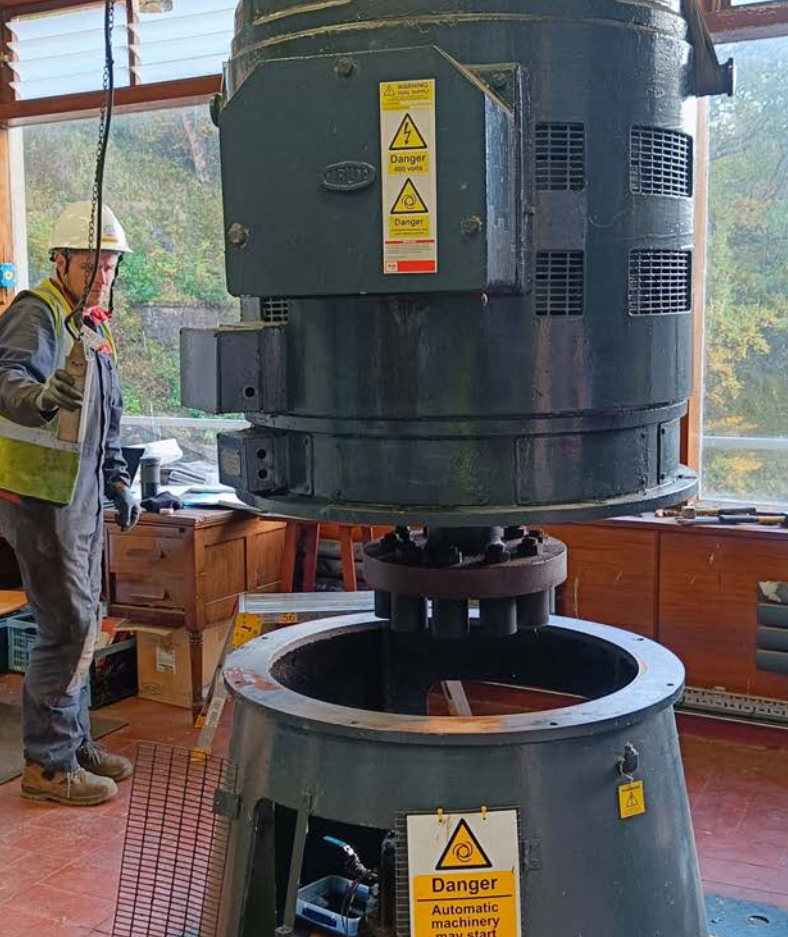
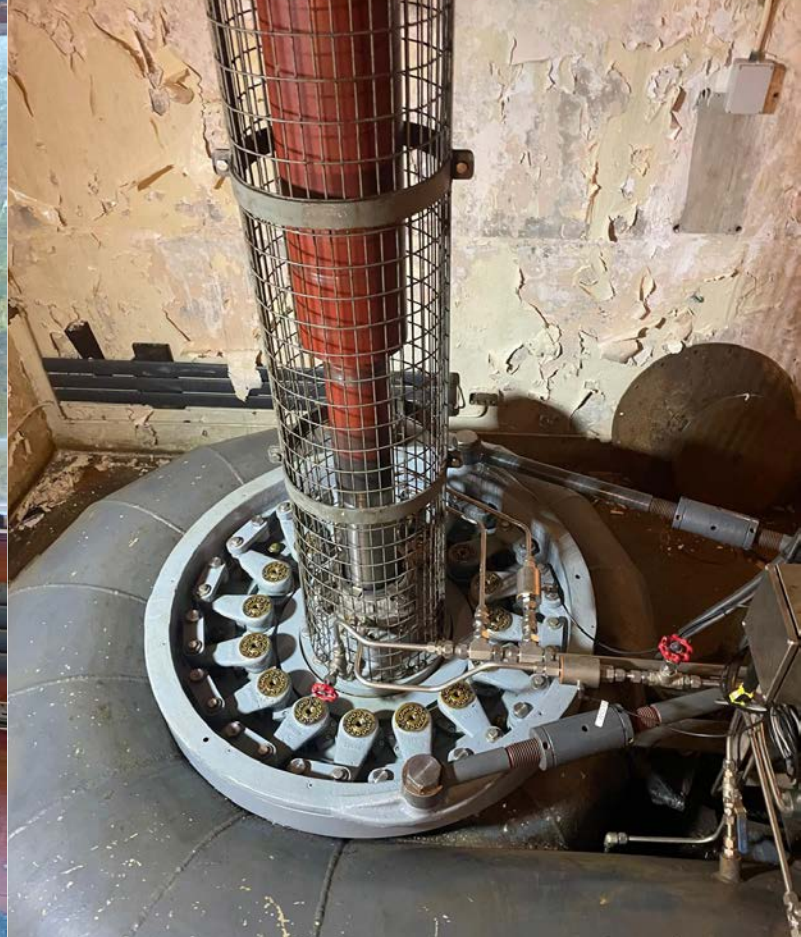
In this case, the machine is split over two floors with the generator mounted at ground level and the turbine located below ground with a 4.2m shaft connecting the two. This configuration meant the turbine assembly had to be lifted through a small hole in the floor to facilitate removal for refurbishment.

Images show generator on upper floor and turbine on the floor below, presenting access challenges.

Because the turbine is housed below ground, we had to build up the turbine assembly in a jig and set the guide vane positions at the workshop in Kendal, then lower the whole assembly into position pre-assembled through the hole in the upper floor. This methodology proved to be successful and reduced the required assembly time on site.

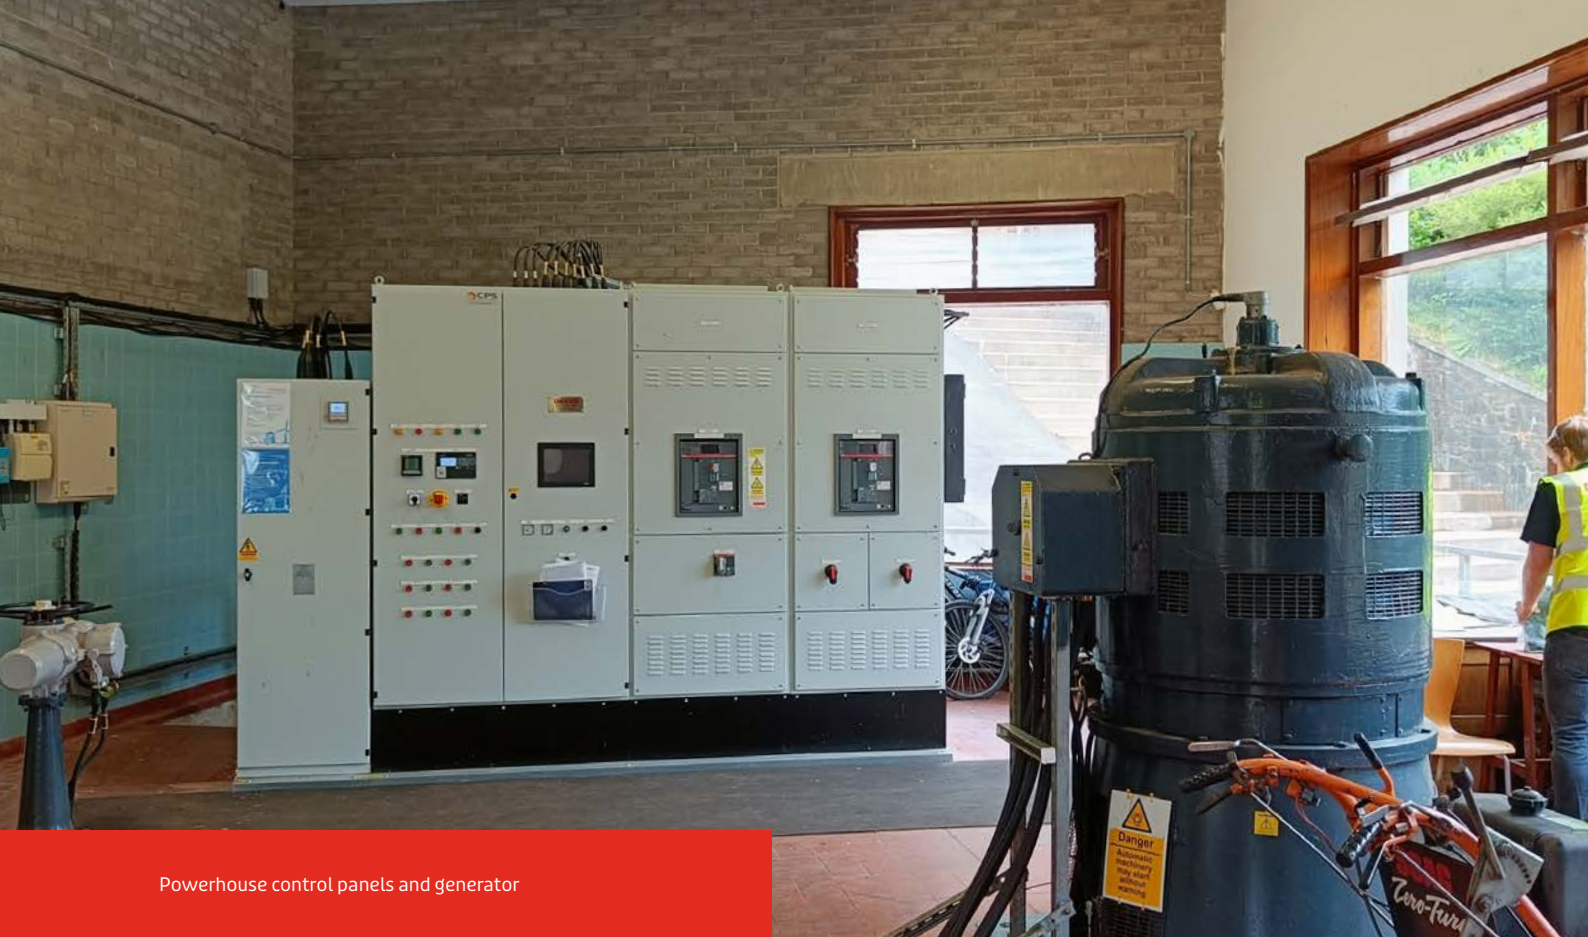
Powerhouse control panels and generator
